Review and Response to the Summer 2007 Floods in the Cotswold District

Second Phase Report

25 July 2008

Report no: 0002-NE02933-WXR-04

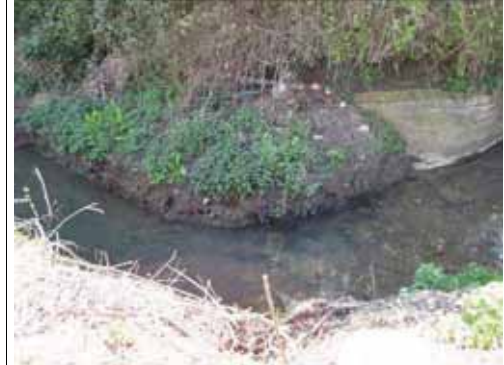
Photograph – The right bank of the River Evenlode, downstream of the culvert from Queen Victoria's Garden (13). Soil has built up (or been placed) against the bank, narrowing the channel width

downstream of the Oxford Street road bridge is heavily vegetated (20). In addition, the right bank at the outlet of the culvert from Queen Victoria's Garden (13) appears to have encroached upon the channel (see photograph above). A resident of Croft Holm has also noted that a fence, erected along the right bank of the Evenlode (21) by Thames Water, prevents maintenance access to the channel and bank. The Environment Agency has reported that, prior to the Summer 2007 floods, the River Evenlode was not included in its maintenance programme. However, it has re-assessed the situation and the river will now be cleared of blockages and trees as required. In particular, annual clearance of the river through Moreton-In-Marsh is programmed for late summer. However, it is important to note that maintenance is unlikely to have prevented the extreme flooding of Summer 2007 (refer to the main report).

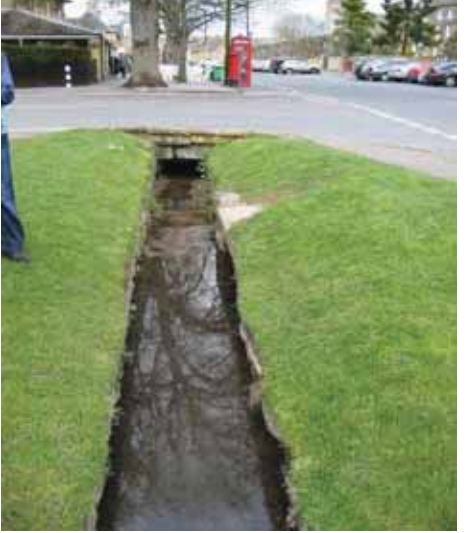
<p><i>Looking at the ditch which runs alongside the High Street through town.</i></p> <p>The ditch takes surface water drainage from the hills to the north of the village, the school fields and Moore Road. Surface water runs into the school playing fields, goes down the ditch onto the road and issues near the war memorial. The banks of the ditch are very low providing minimal freeboard above the water level and the top of bank. The ditch overtopped during the flooding resulting in water flowing onto the High Street.</p>

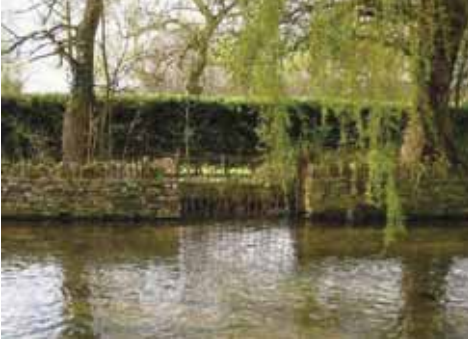
<p><i>Looking at the right bank of the River Windrush from High Street.</i></p> <p>The bricked up hole in the wall just downstream of Birdland prevented water from flowing through the field into the water meadows. This resulted in the loss of possible flood storage in the meadows and exacerbating the flooding on Rissington Road.</p>

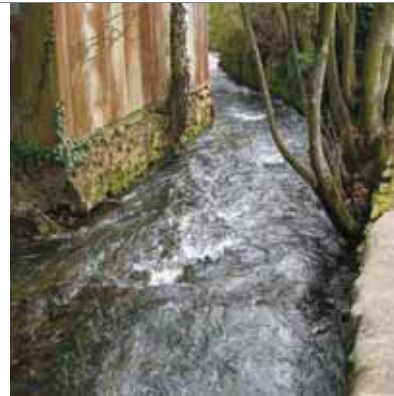
Birdland needs to ensure the trash screens are free of vegetation to allow the flow to get through the area. During the flooding grass from the catchment blocked the trash screen.

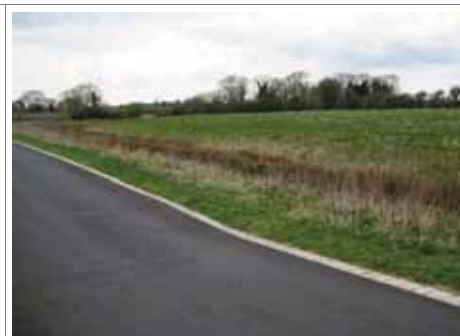
Overgrown swale next to the access road from the A417 to the Butlers Close development.

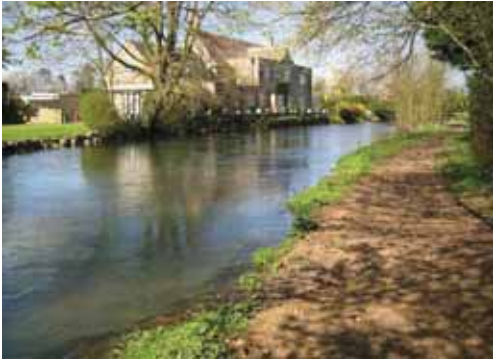
<p><i>Looking downstream at the River Coln from Milton Street Bridge</i></p> <p>The gap in the wall before the Bull Inn, allowed water to flow onto High Street during the flooding.</p>

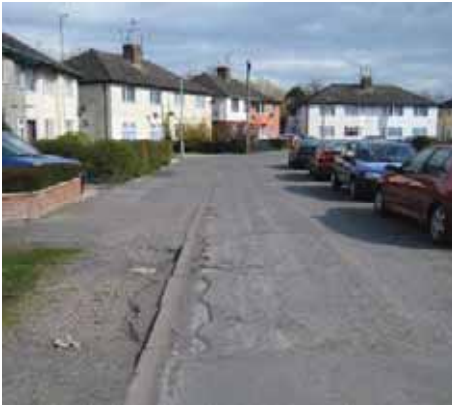
<p>Nursery close flooded from surface water during the 2007 floods. Local residents view that the Love Lane Industrial Estate is the source of the majority of the surface water runoff.</p> <p>The industrial estate generates a high level of surface water runoff due to the high amounts of impermeable surfacing in the area. Nursery Close and Siddington Road are located down gradient from the industrial estate and the surface water flows from the industrial estate and into the Nursery Close and Siddington Road.</p>

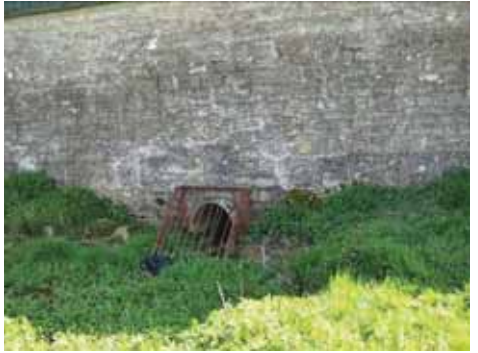
<p><i>The Cirencester Road (A429).</i></p> <p>The Cirencester Road floods regularly, as the road has very poor drainage, as a result the water flows directly into the town along the High Street. During the flooding surface water from the surrounding fields flowed down the road and into the town.</p> <p>There used to be open drains along the main road which ran through the town. Local opinion is since the drains have been filled flooding in the town has got worse.</p>

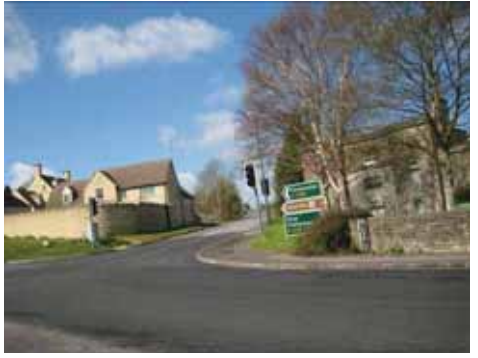
<p><i>The road level is the same height as the kerb on College Row.</i></p> <p>Road resurfacing has caused the road level to be raised to the height of the kerb along many roads throughout the town. The road drainage is poor and this results in the roads flooding on a regular basis. The height of the road in relation to the kerb resulted in water flowing directly into properties from the roads. The areas worst affected by this are Mill End, College Row and the High Street.</p>

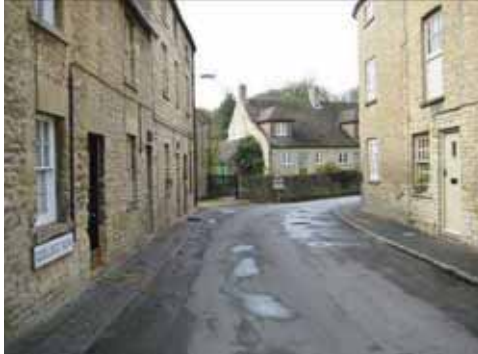
Dropped kerb and heightened road level on the High Street.

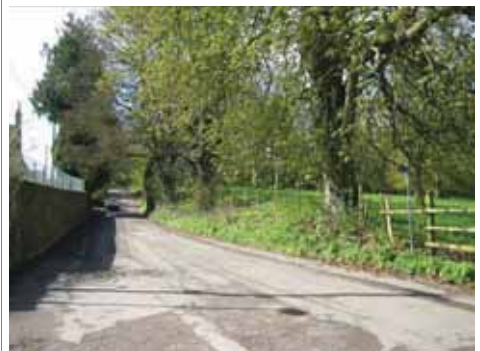
Blocked drain at the bottom of School Hill.
