WILD Project

Rivers Management Plan

for Fairford Parish

May 2016

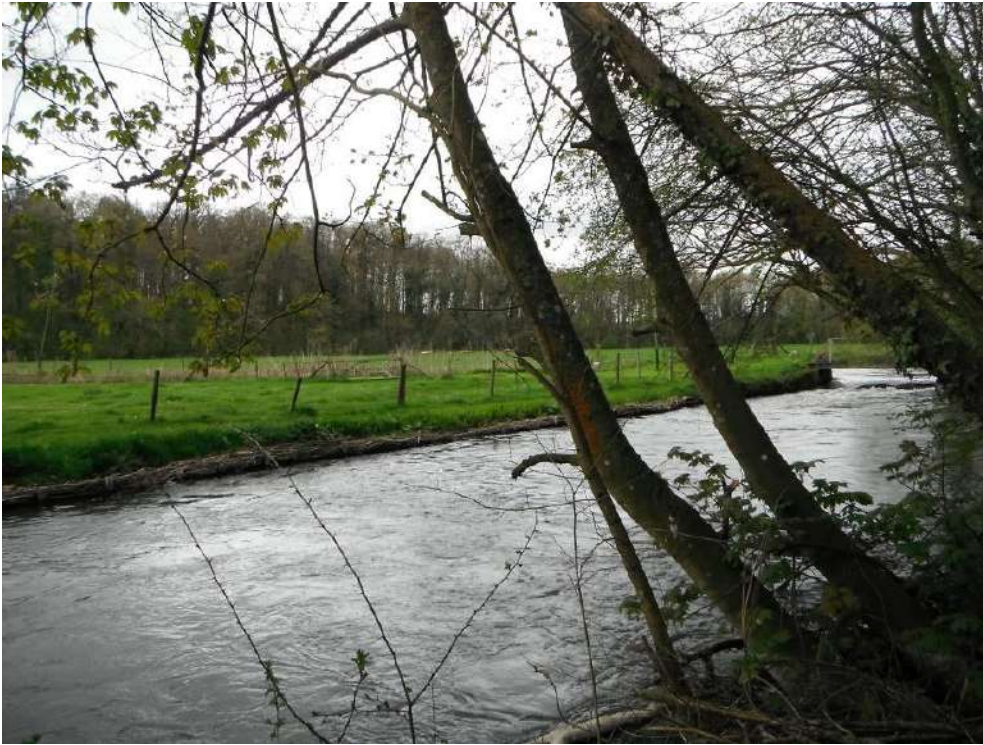
Photo 1 the river at the most upstream end of the Fairford parish is very wide straight and shallow and the adjacent land use is arable

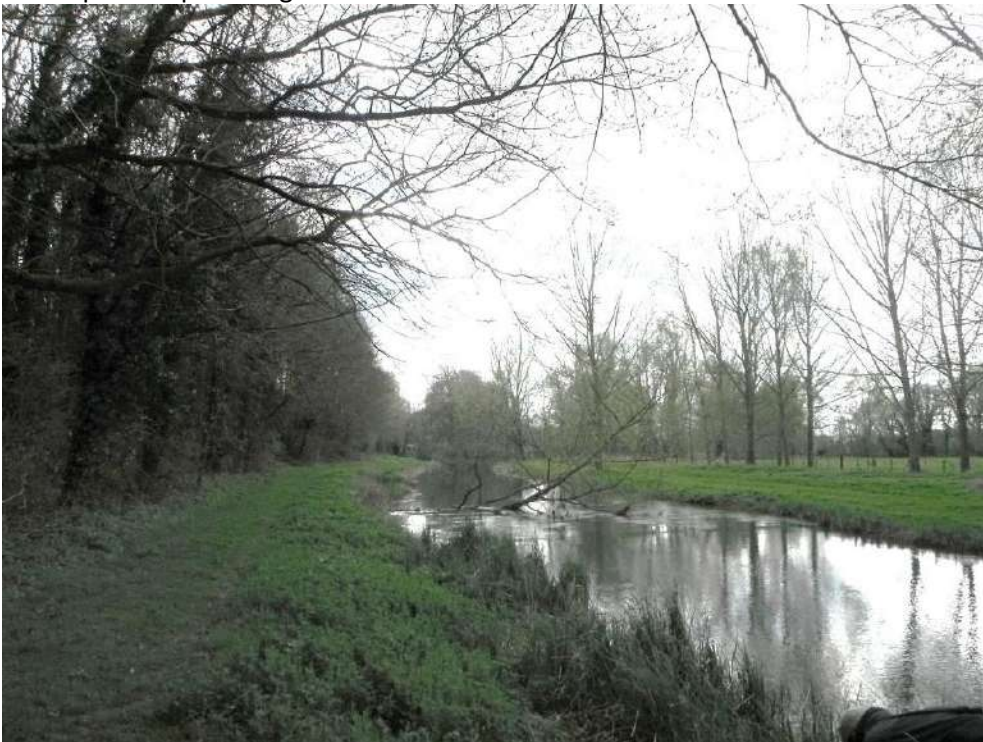
Photo 2 the river is overwide and straight providing a very poor variety of habitats; however there is some Large Woody debris present providing some variation

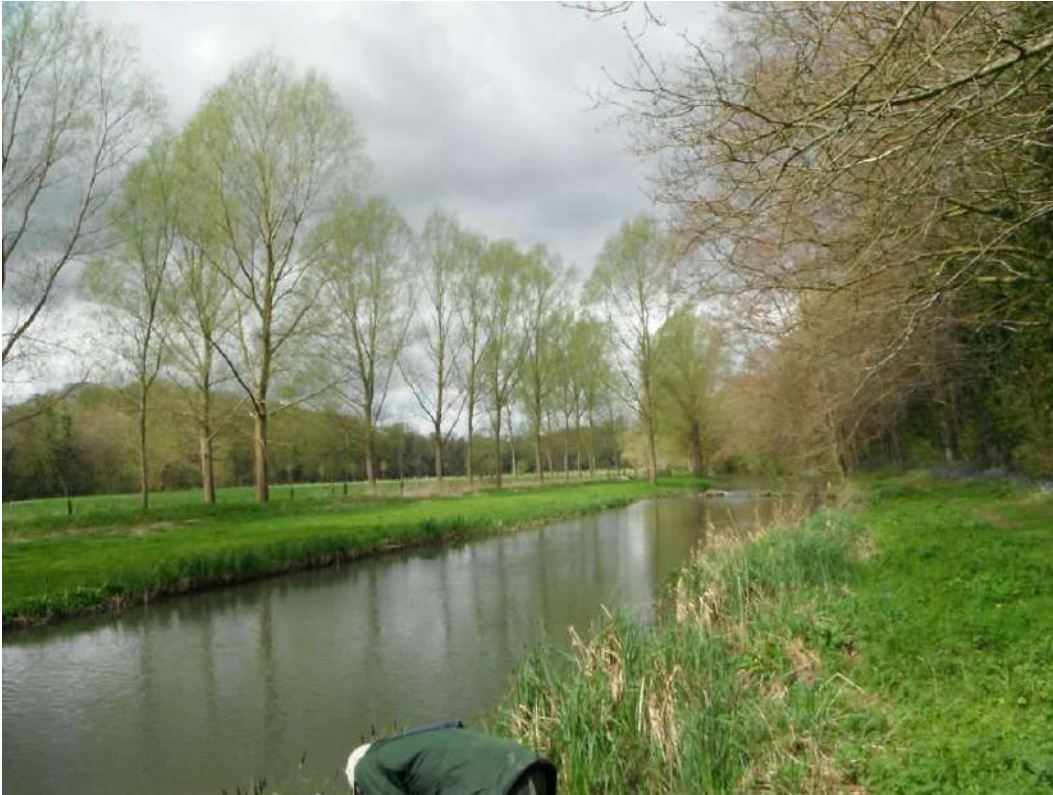
Photo 3 the river is still over wide shallow and straight with no variation in the habitat

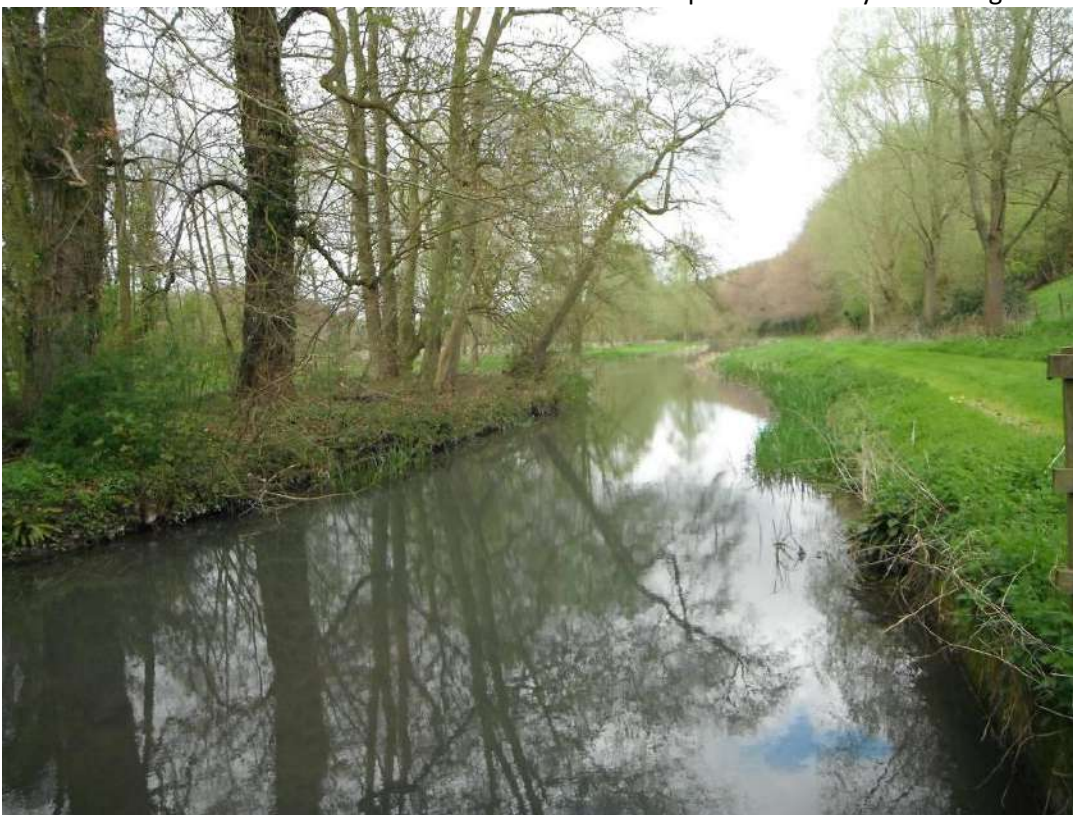
Photo 4 the river here has a island in the middle which improves flows by narrowing the river to two channels

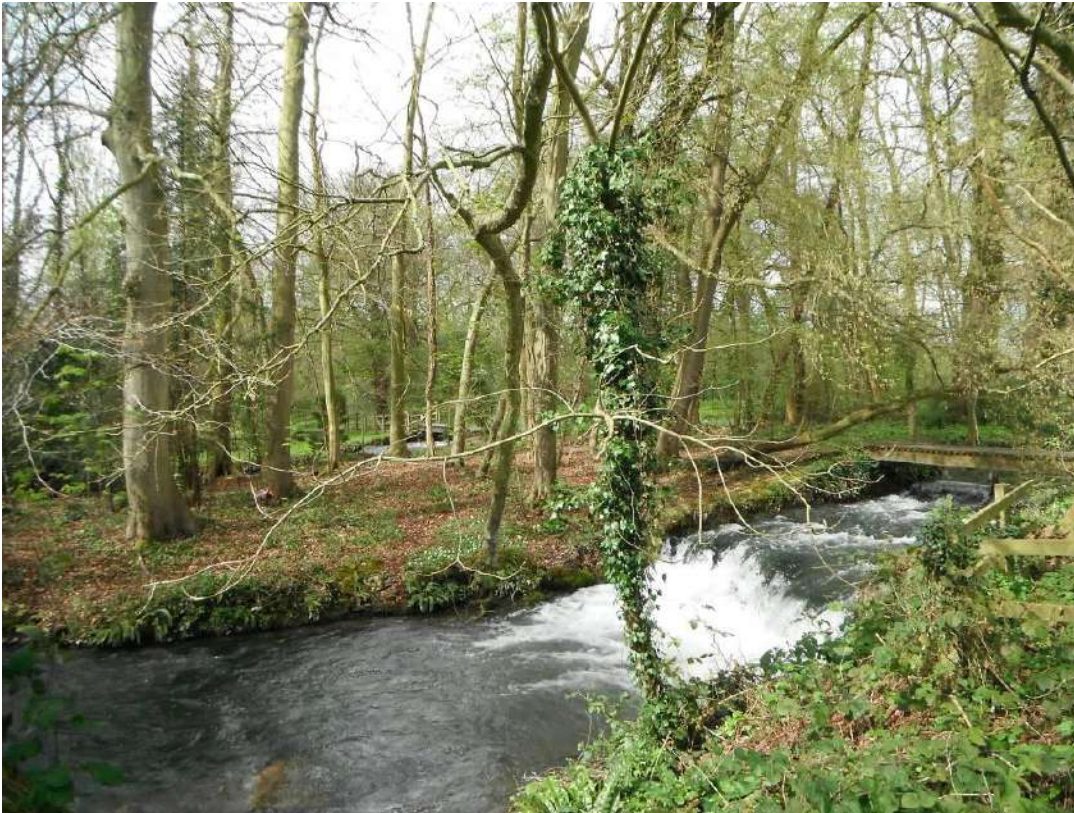
Photo 5 at the downstream end of the island there are two weirs which are obviously one of the many barriers to fish migration along the River Coln

There are three barriers/constraints to fish movements/migration within the parish of Fairford, two at Fairford and one at the top of the Broad Water. Any modification or removal would obviously require a high level of landowner co-operation which may difficult when high levels of fish stocking are routine.

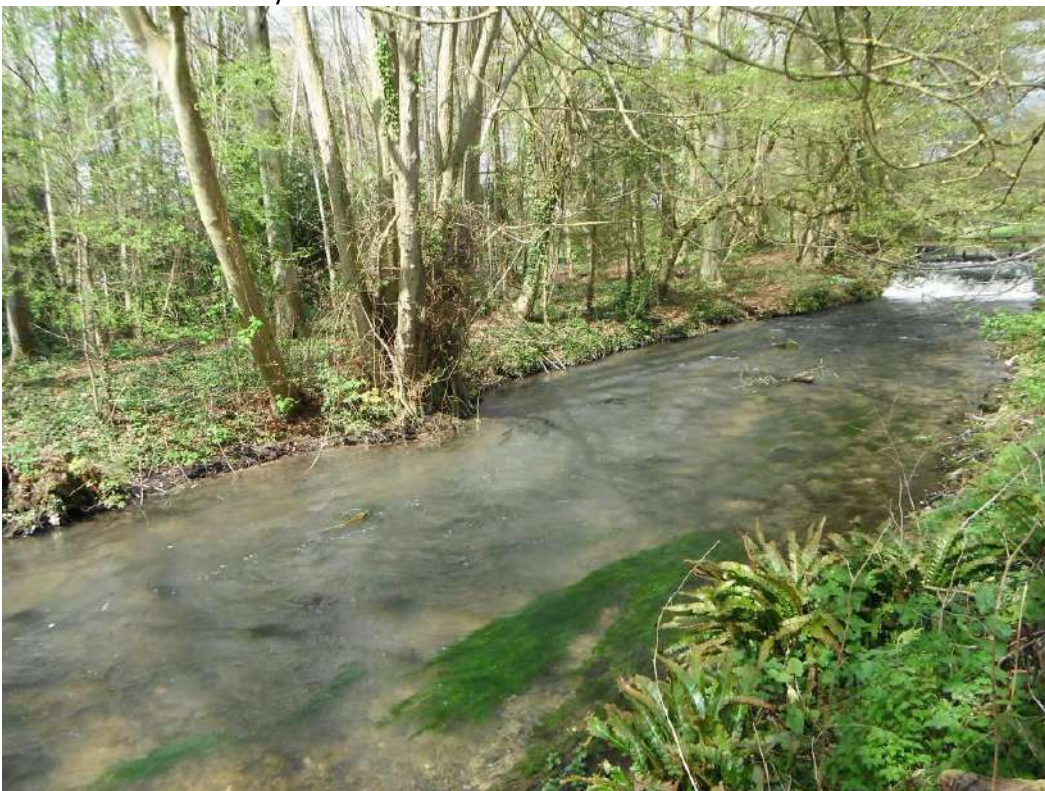
Photo 6 where the island narrows the channel has better flow allowing aquatic plants like *Ranunculus spp.* to grow this however this is the only area it was noted

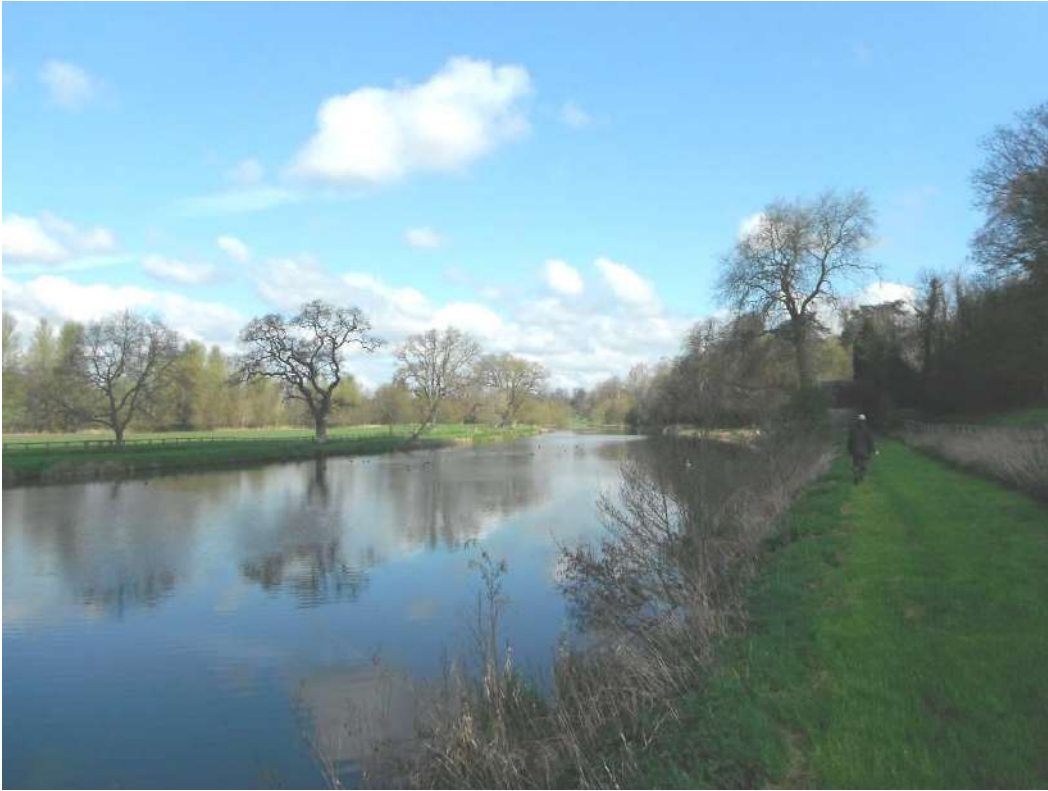
The over half of the river through the Fairford parish has been subject to major modification to its morphology it being effectively dammed by the mill at Fairford thereby creating an online lake within Fairford Park where the river (called Broad Water) would have naturally had been. This changes the ecology of the habitat to that of standing water rather than a river which obviously changes the species that can thrive in this habitat.

Photo 7 this photo taken of the Broad Water section of the river shows how the river has effectively been dammed to create an online lake, obviously this will not provide a suitable habitat for river species like wild brown trout hence the requirement for artificial stocking but would suit Carp

There is a small channel that runs parallel to the river through Fairford Park which is closer to a river habitat, if this channel could be enhanced to create meanders via re-routing or the introduction of large woody debris and gravel it could potentially provide a connecting habitat for river species past the unsuitable Broad Water.

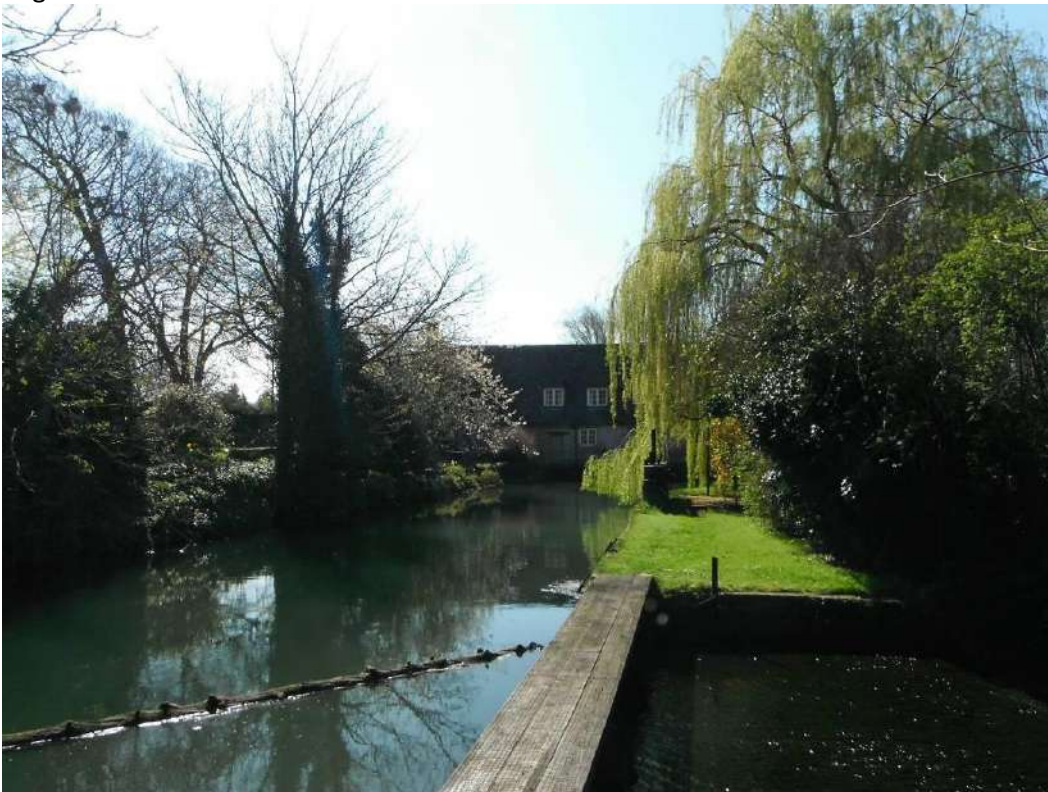
Photo 8 shows the Mill at Fairford which is effectively the dam on the Broad Water and also another barrier to fish movement, the channel here is actually split in two with a bypass channel which may be easier to modify for fish migration

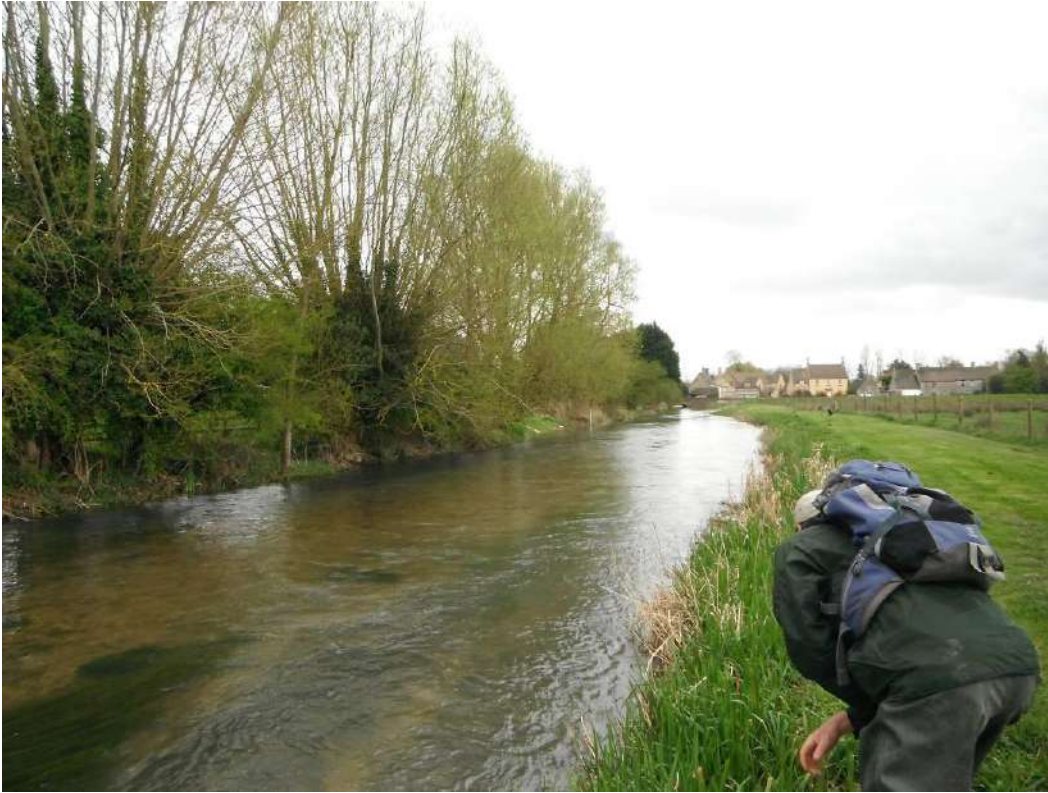
Photo 9 the River in Fairford between the Mill and the main road bridge is again overwide, straight and shallo. It did have good marginal vegetation for species like water vole but was not ideal for natural fish populations although one fisherman reported regularly catching Grayling here.

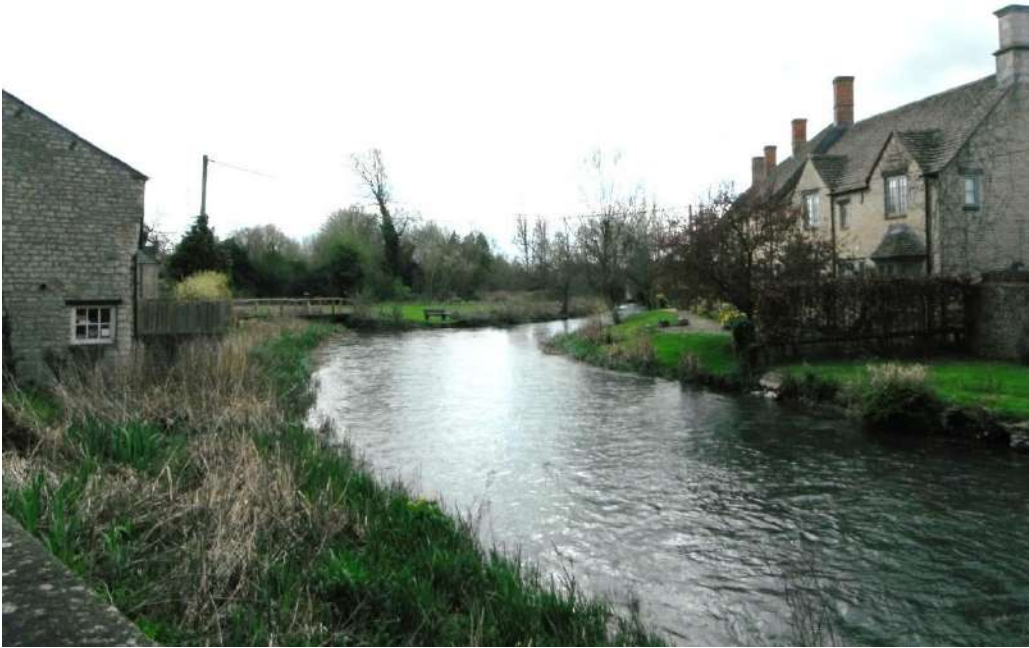
Photo 11 downstream of the bridge there are some homes built very close to the river and the channel soon splits again to indicative of another historic mill site.

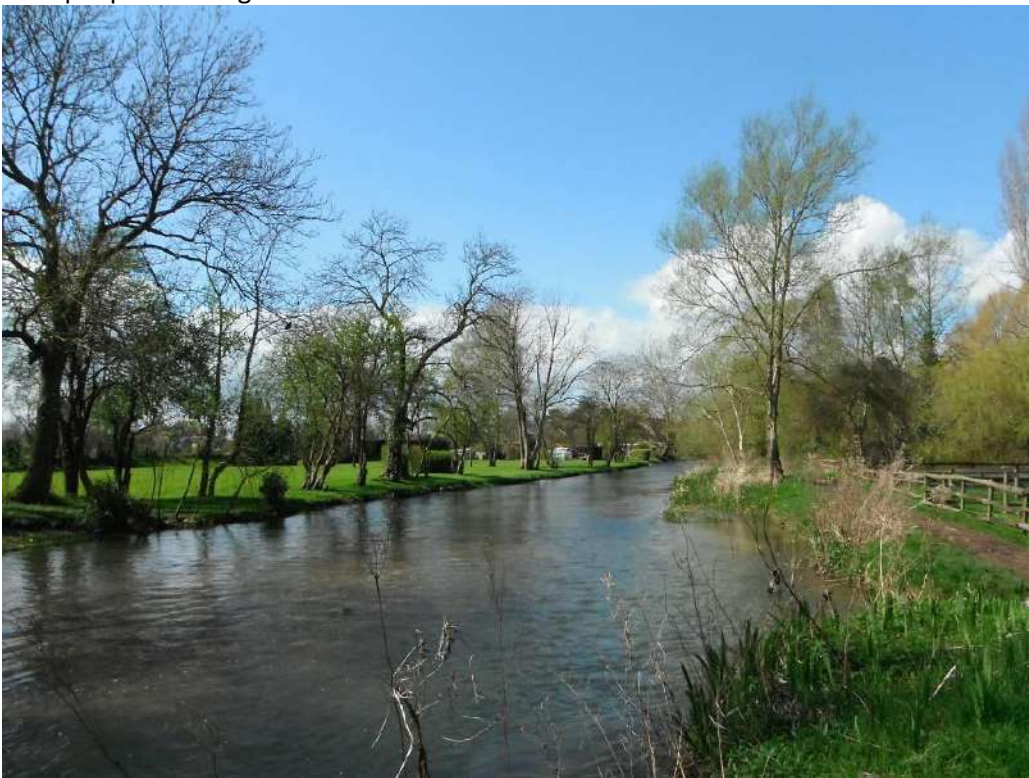
Photo 12 the river downstream of the town is still overwide and straight but it does have footpaths alongside it meaning local people have a good connection to the river

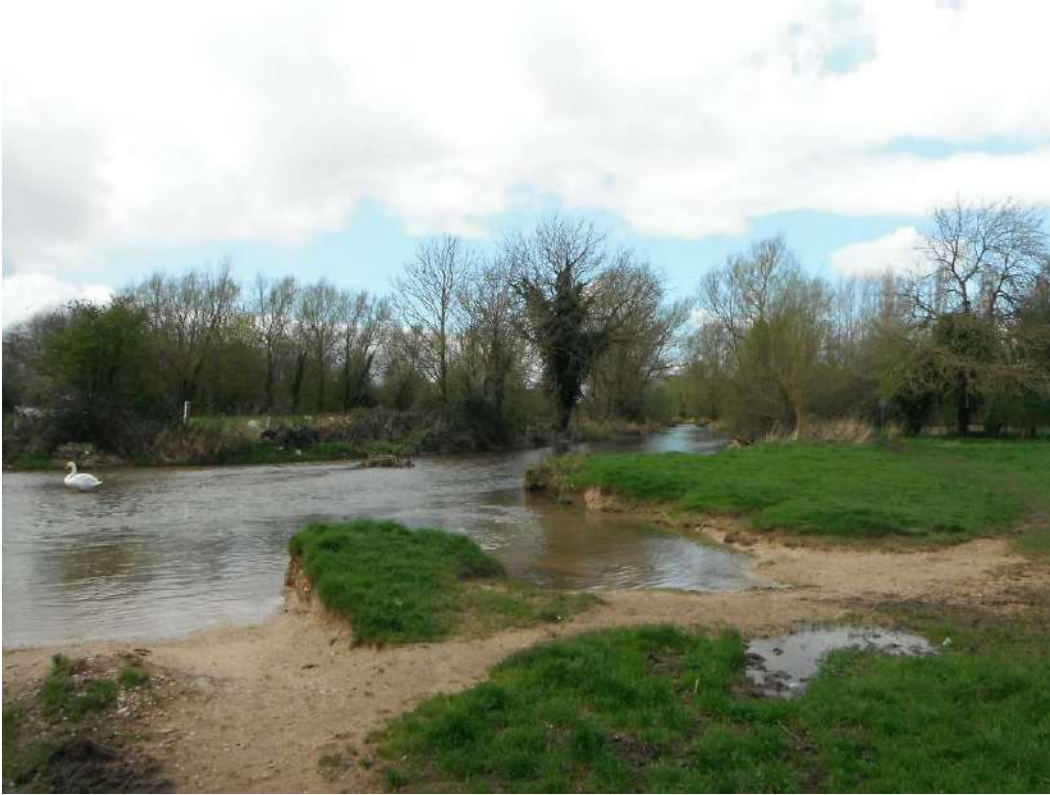
Photo 13 as the river moves away from the town the land becomes more pastoral here the banks have been damaged by vehicle access across the river

There are some sections along an associated channel of the River Coln where riverside fencing would be beneficial to the ecology of the river because the bank was damaged by livestock accessing the water to drink and cool down. This damages vegetation eventually leading to increasing erosion of the banks and pollutes the water via sediment/mud being washed into the river.

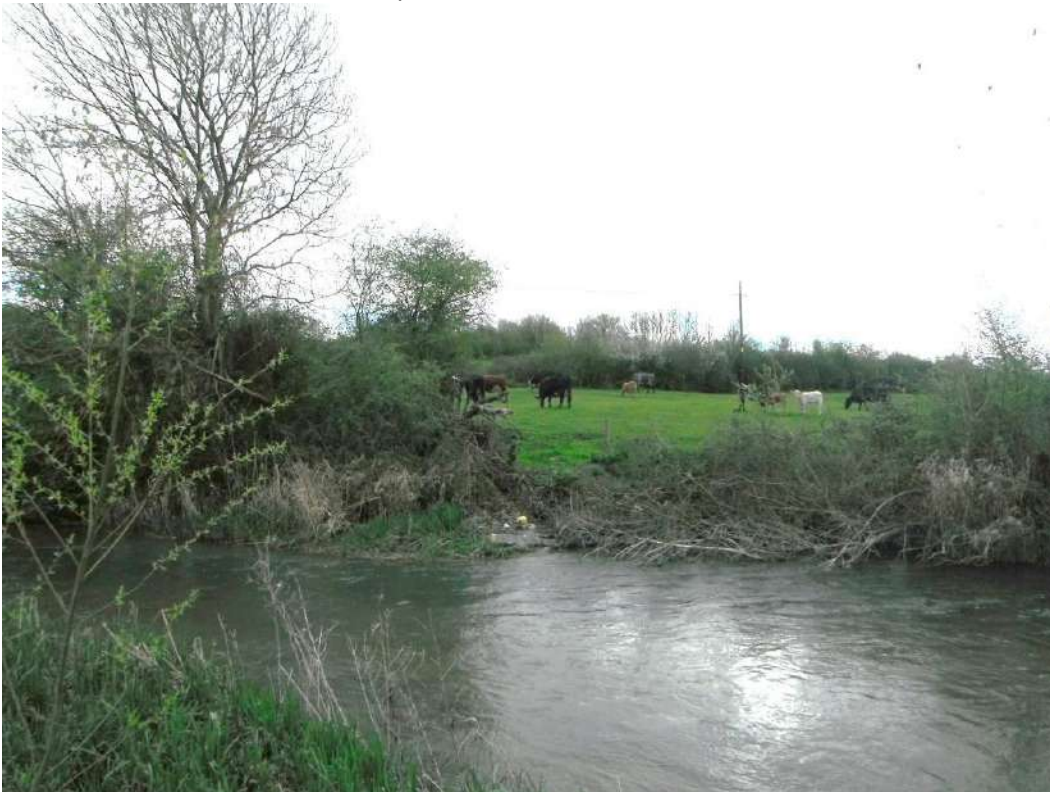
Photo 14 yet again the river returns to its over-wide, straight form overall the river was one of the most featureless sections of river within the waterpark area

The Coln is has some good morphological sections in the upstream section of the Fairford Parish however the straighter sections which would benefit from Large Woody Debris deflectors and channel narrowing works. Creating structures such as simple log-berms or flow deflectors to narrow the channel diversify the flow of river currents, scour gravels or adding gravel to create a more diverse river habitat is key to supporting species like native wild Brown Trout. See Appendix 5: WTT Manual Large Woody Debris.
