Review and Response to the Summer 2007 Floods in the Cotswold District

Second Phase Report

25 July 2008

Report no: 0002-NE02933-WXR-04

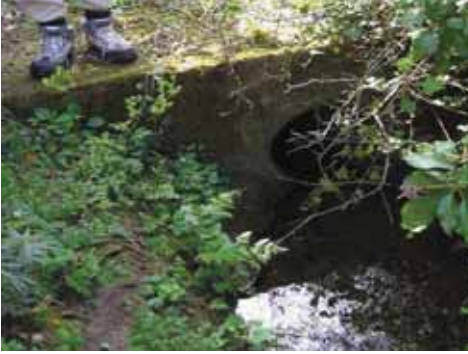
Description of Mechanism	Photograph
<p><i>Looking downstream at the CDC ditch culvert.</i></p> <p>CDC ditch (at Clapton Hill) runs from Clapton Hill Road, there is a restriction of the flow under the road in the form of a short culvert. The constriction results in water backing up through the ditch during high flow.</p>

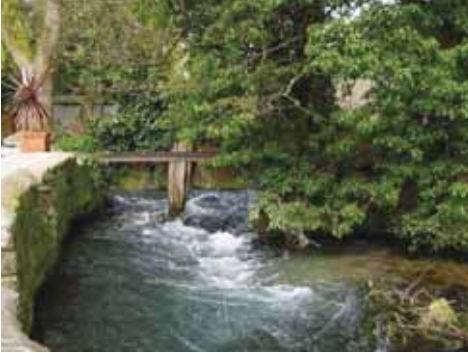
<p><i>Looking upstream at the redundant sluice from the Duke of Wellington car park.</i></p> <p>A redundant sluice gate at the rear of the old mill (presently the motor museum) was inoperable in the open position. The sluice gate restricted flow, causing river levels to back up, resulting in the flooding of the museum and properties upstream. Flood water flowed through the Manor House and onto High Street. The water then combined with water flowing down Sherbourne Street.</p>

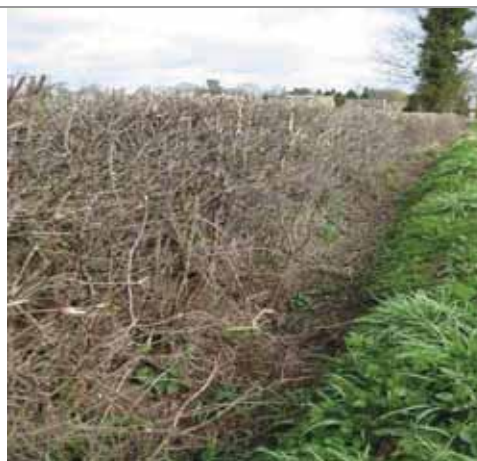
Looking at a ditch in Bourton.

During the flooding there were poorly maintained ditches throughout the town which were blocked by debris or obstructions which exacerbated the flooding. Overflowing drains were reported during the flooding.

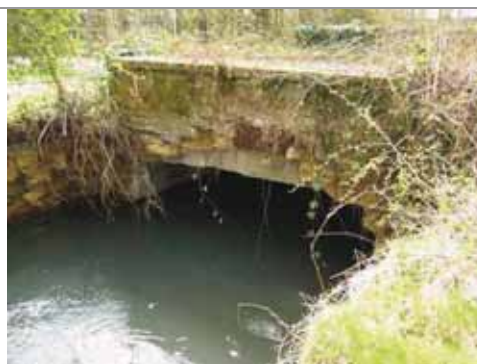
Looking downstream of the River Dicker at the old road bridge.

There is a pinch point where the water flows under the old road bridge. The bridge restricts the flow resulting in water backing up into the lakes (into Lake No1 then Lake No2).

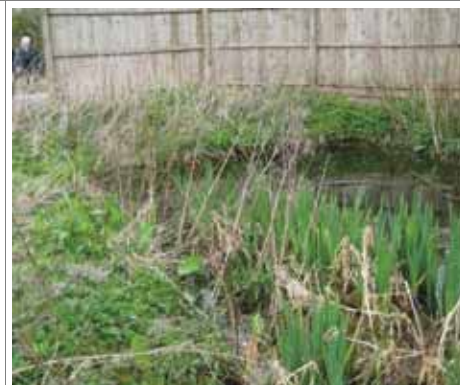
Standing water from an unconnected pipe in the Butlers Court development.

GCC have confirmed the surface water system in the development was not connected to the main surface water drainage in locations. This is resulting in uncontrolled discharge issuing onto the land.

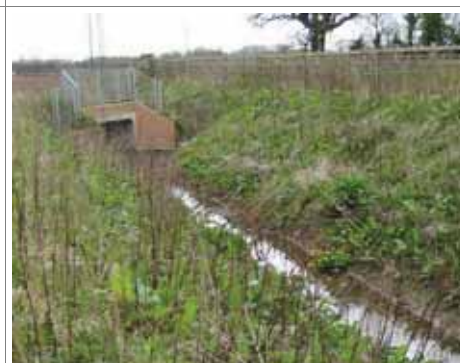
Looking upstream of the ditch leading to culvert under the roundabout.

When the new roundabout was constructed new culverts were installed under the roundabout. There were reports the flood relief ditch constructed by GCC to convey flows from the roundabout around the town during high flows was blocked during the flooding. Flood water flowed down the ditch alongside the main road and exacerbated flooding downstream.

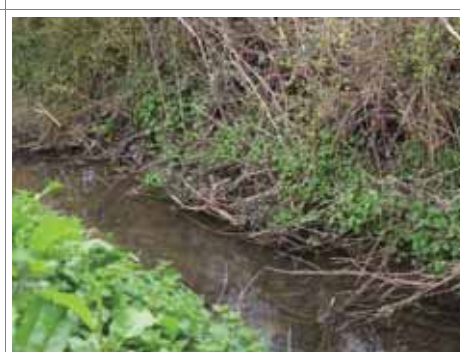
The ditch which runs alongside the A417.

The A417 road was flooded, past the garden centre to the veterinary surgery, as the drainage on the road was not functioning. The ditches were silted up, overgrown and as a result not functioning properly.

E	<p>The Downington Ditch requires regular clearing, especially in the reach along the main road, to ensure the ditch is at maximum capacity to convey flows.</p> <p>Review the disposal method for debris removed from land drainage ditches.</p> <p>The EA maintains the Downington Ditch on an annual basis.</p>
F	<p>The Priory Lane caravan park requires a flood resilience and flood emergency plan, to reduce the impact of future flooding.</p>
G	<p>Promote self-help and non-structural approaches to flood risk management (refer to the main report).</p>

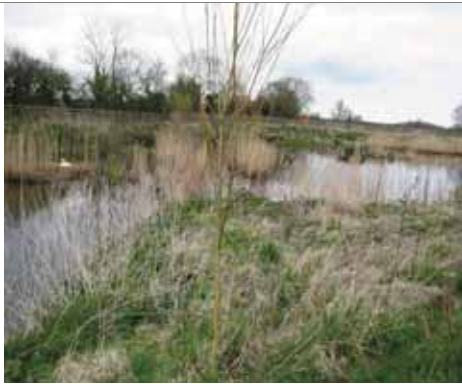
A sharp bend in the course of the drainage ditch on the A417.

The bend is a critical low point along the main road. The bank of the ditch is very low and is likely to breach at this point. The main A417 road floods regularly (annually) due to poor highway drainage.

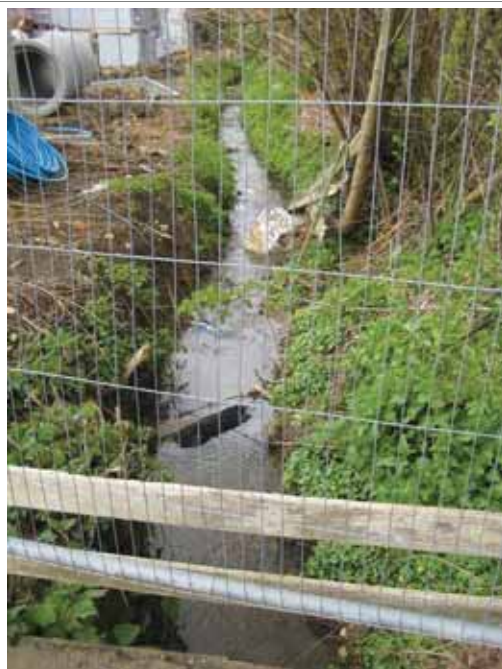
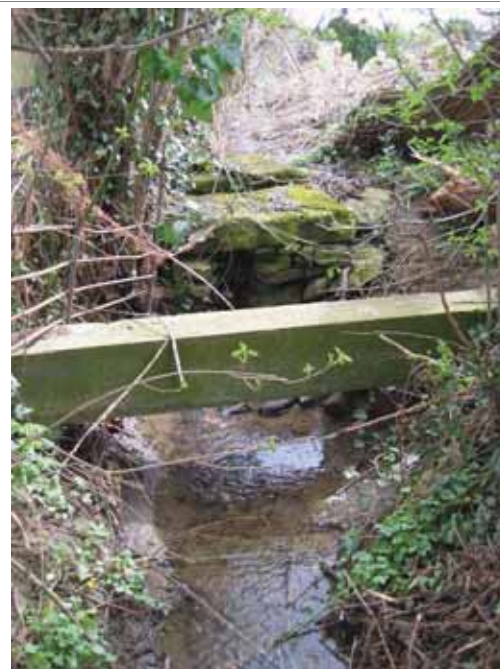
Photographs – The watercourses in the vicinity of the new development (7)

Five new houses are currently being constructed on land (occupied formerly by a motor caravan manufacturer) to the west of Timms Green (**7**). The Parish Council is concerned that this development will exacerbate the flooding problem. It is unclear whether the Planning Application for the development was supported by a Flood Risk Assessment, although the proposal submitted at the planning stage did include the opening up of an existing culvert.

Recommendation	
A	Ensure that the construction of the new development (7) includes appropriate mitigation measures to reduce the risk of flooding both to and from the site
B	Ensure that the un-named watercourse, which flows north-westwards through the village, is maintained and that the trash screens are inspected and cleared regularly
C	Examine the cause of the blockage that occurred to the south of Frampton Drive (5), and take any necessary remedial action
D	Undertake a condition survey of the culverts under Campden Lane and Broadway Road. Remove any blockages and make necessary repairs
E	Review the disposal method for debris removed from land drainage ditches
F	To reduce the risk of flooding to Timms Green, investigate the feasibility of creating a temporary flood storage area in the playing field (12) adjacent to the watercourse (this may require hydrological and hydraulic assessment of the watercourse)

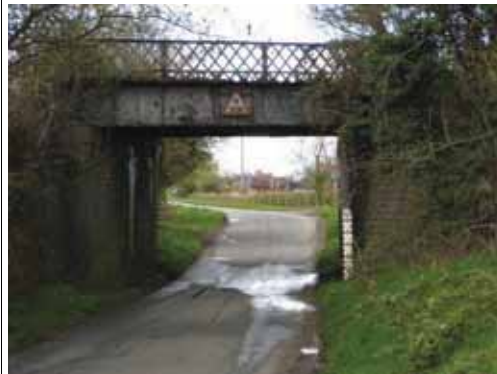
Manhole covers on Badsey Lane were lifted due to surcharging (9). The overland flow collected in a low spot in the road, under the disused railway bridge (10). The Parish Council has reported that the water reaches a depth here of around 1 m, even following only moderate rainfall. Severn Trent Water has admitted that the capacity of the sewage pumping station (11) is inadequate and has promised to take action in Summer 2008.

The railway line is now disused and has been transformed into a cycle route by Sustrans. The Parish Council has reported that, since the railway was abandoned, the drainage openings through the embankment have not been maintained. This may have exacerbated the build up of surface water in the village.

*Photograph – Railway bridge over Badsey Lane.
Surface water run-off collects in this low spot (10)*

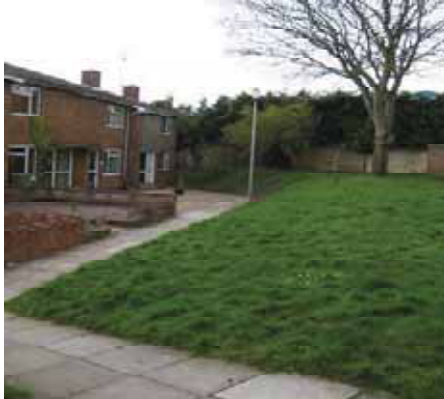
<p>Nursery close flooded from surface water during the 2007 floods. Local residents view that the Love Lane Industrial Estate is the source of the majority of the surface water runoff.</p> <p>The industrial estate generates a high level of surface water runoff due to the high amounts of impermeable surfacing in the area. Nursery Close and Siddington Road are located down gradient from the industrial estate and the surface water flows from the industrial estate and into the Nursery Close and Siddington Road.</p>

<p>D</p>	<p>The runoff generated by the Love Lane Industrial Estate should be investigated. If the development is found to generate significant runoff, measures could be taken to reduce the runoff from the estate by attenuation.</p>
<p>F</p>	<p>The EA have investigated the Watermoor area north of the ring road and a strategy has been developed which has been approved. CDC should work with the EA project team to ensure all areas are covered as part of this strategy and collaborate where possible. The EA have investigated the cost/benefit ratio the scheme and funding may not be able to be obtained for the scheme to progress.</p>

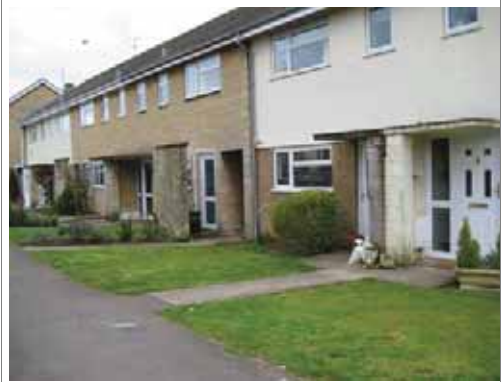
Drains are regularly overwhelmed on Countess Lillas Road. The area has a long history of surcharging resulting in flooding from surface and foul water. The soakaway in the field behind the road could be under capacity and need extending. The area has a very high water table and recently built developments have flooded from ground water flooding.

All drains on the road go to the soakaway located in the field behind the road. The area has a foul water flooding problem and flooded from foul and surface water during the 2007 floods. Due to the recent development in the area there are uncertainties regarding the connections into the soakaway.

<p>A</p>	<p>Melmore Gardens, Rose Way, Southmead Close, Countess Liliat Road and Alexander Drive require a drainage survey to be completed to assess the capacity of the drains. If the drainage is found to be inadequate, improvements should be made to the drainage network to reduce the risk of flooding.</p> <p>GCC has reported that a drainage pipe under Siddington Road has collapsed in sections and is of insufficient capacity. The poor condition of the pipe is contributing to flooding to the east and west of the road. This requires investigation by Thames Water.</p>
<p>B</p>	<p>As a short term measure all of the drains in the areas affected by flooding should be regularly inspected and maintained on a regular basis.</p>
<p>C</p>	<p>The soakaway located in the field behind Countess Liliat Road should be investigated to check the connections into the soakaway and to determine if the capacity of the soakaway needs increasing.</p>

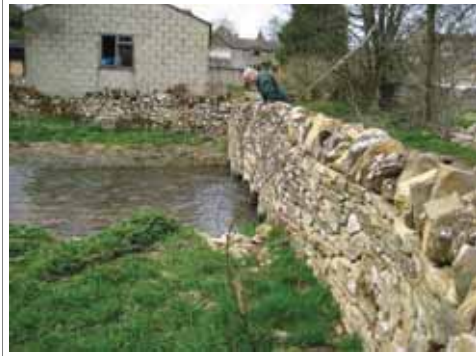
Looking at the Dovecote Bridge from the road.

The bridge has 3 small orifices which hold back water during high flows on the Dovecote floodplain. If the capacity of the floodplain is exceeded, in previous events, water has flowed through a gate by the bridge and joined the river downstream of the bridge. During the flooding the gate was blocked by grass which had recently been cut and water could not rejoin the river downstream. Subsequently the river flowed over the left bank onto the main road and flooded properties.

E	During flood events ensure the gate is left open to the right of the bridge, to ensure there is no obstruction to flow. There is an option to install an overflow drain over the road at the Dovecote bridge to reduce water build up on bridge, to allow the flow to rejoin the river downstream and to avoid water flowing onto the main street over the left bank.
F	The Dovecote floodplain acts as a flood storage area during high flows. To ensure the capacity of the area is maximised it is essential riparian owners maintain the river bed and banks to ensure they are free of overhanging vegetation, debris and obstructions. Planting of the floodplain is not advised, as in the long-term effect will be to reduce the capacity of the floodplain. Debris from planting in the floodplain could result in the small orifices on the bridge becoming blocked, resulting in water building up in the floodplain during low flow conditions.

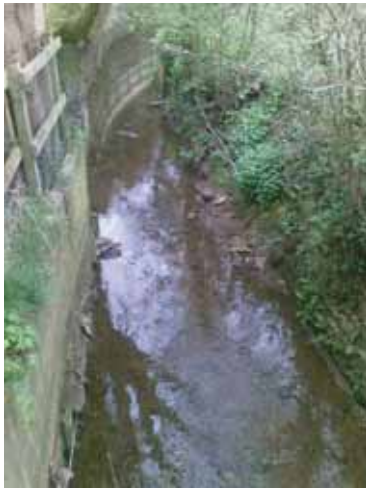
<p><i>Looking downstream from the road bridge.</i></p> <p>Ditch is generally clear downstream, however banks tend to be overgrown and difficult to access in some locations. The ditch makes several right angle turns before being allowed to meander towards Ampney Brook. Fences that cross the ditch are also thought to catch debris and impede flows during storm events¹.</p>

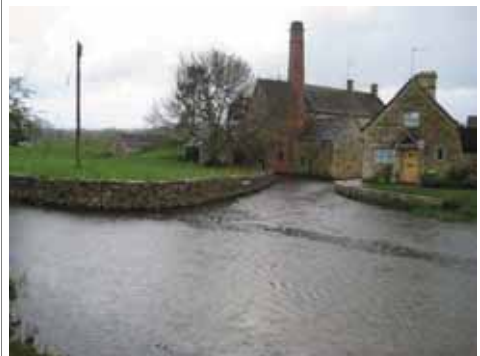
Looking upstream at the confluence of the mill pond and the River Eye (mill at centre of photo).

The water discharging from the mill pond enters the River Eye at this point. During high flows, water from the pond hits the outside wall of the cottage (shown to the right) and in July contributed to flooding not only this cottage but adjacent properties.

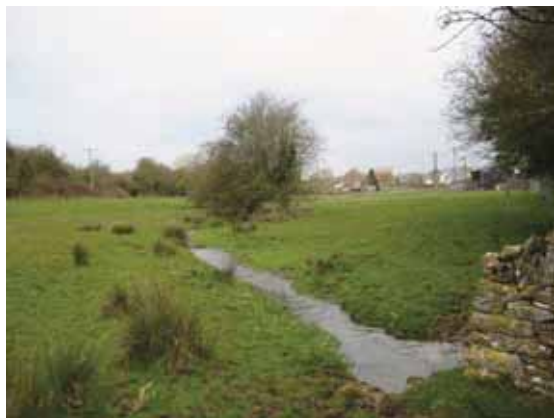
Photograph –View of right bank tributary, looking north-west towards the embankment. Water built up in this field before spilling into the village centre

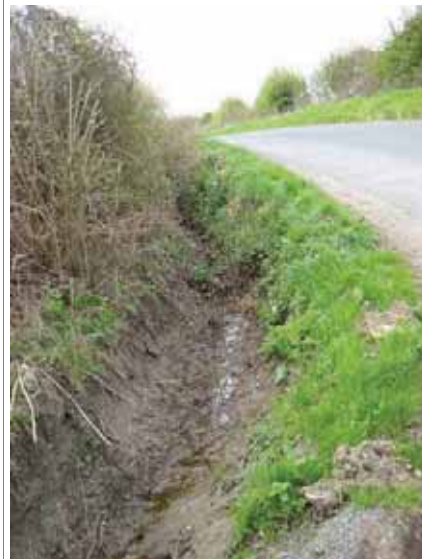
Photograph – A roadside ditch at the Standing Cross Lane junction (6). This ditch has been cleared since the Summer 2007 floods

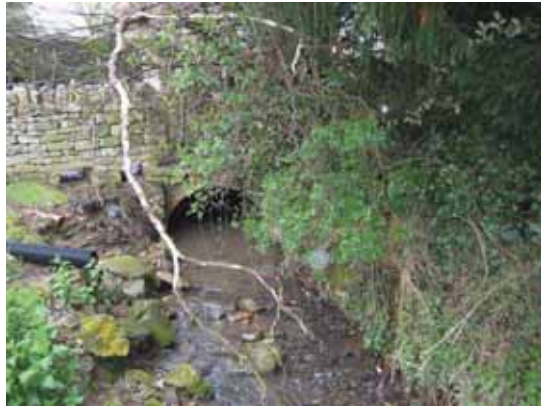
Zone 3 – The restricted course of the Coombe Brook between Parsons Lane and Friday Street

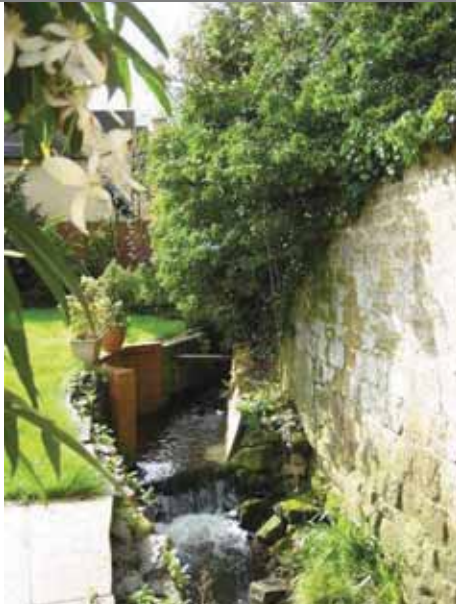
Zone 4 – Upstream face of the Coombe Brook culvert under Friday Street (9)

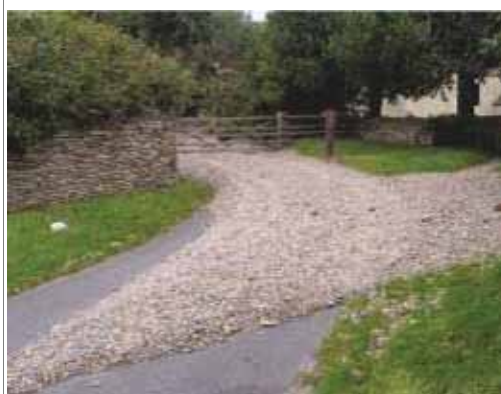
Photograph courtesy of Raymond Coleby – Gravel transported by the surface-water run-off (7)

Run-off also transported gravel from a private driveway, adjacent to the church (7).

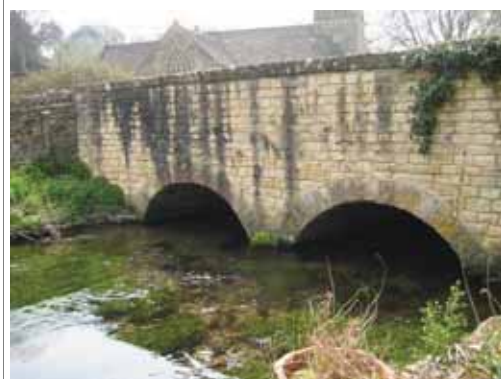
Photograph – Upstream face of the road bridge connecting Eastleach Turville and Eastleach Martin

The River Leach, which flows in a general southerly direction through the village, is designated main river downstream of the road bridge (8). The topography of the village rises steeply from the river and, as a result, only two properties were flooded by it. A resident who has lived in the village for 25 years, reported that the normal summer level of the river is now higher than in the past. He also expressed concern regarding the impact of sluice gate operation in the wider area on the river level in the village.

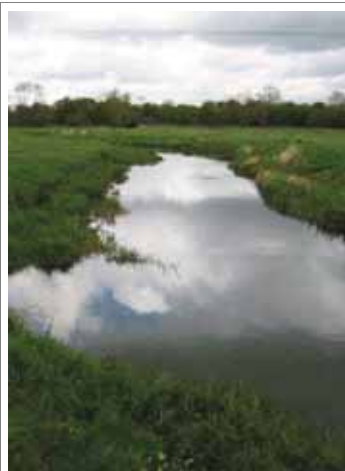
Adjacent fields (left, right and photo location) were inundated subsequent to the river overtopping its banks. The area is very flat with shallow river bed gradients. Once this area reaches capacity backwater effects are conveyed upstream which prevents the main river from the village from discharging.

The sewer treatment plant is located approximately 50m downstream from this location however it was not reported as having flooded.

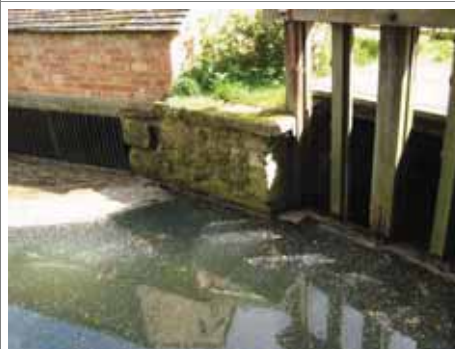
At the Mill downstream from the confluence of the Bledington Brook and the Evenlode. Looking north-east towards the grated culverts under the road (B4450).

Typically of Mill systems, two culverts flow underneath the mill building while one culvert diverts the flow away from the mill when not in operation. Residents in the village believe that the mill constrains the flow and prevents the Evenlode from draining adequately therefore contributing to the backwater effects in the village. The penstocks look to be operational however it is unknown whether it is controlled during storm events.

During July 2007 hay and straw was washed from the catchment and was caught against the grates.
